National Park Service properties within the Downtown DC Business Improvement District

a brief analysis of existing conditions and potential improvements

Prepared for the
DC Downtown Business Improvement District

2009

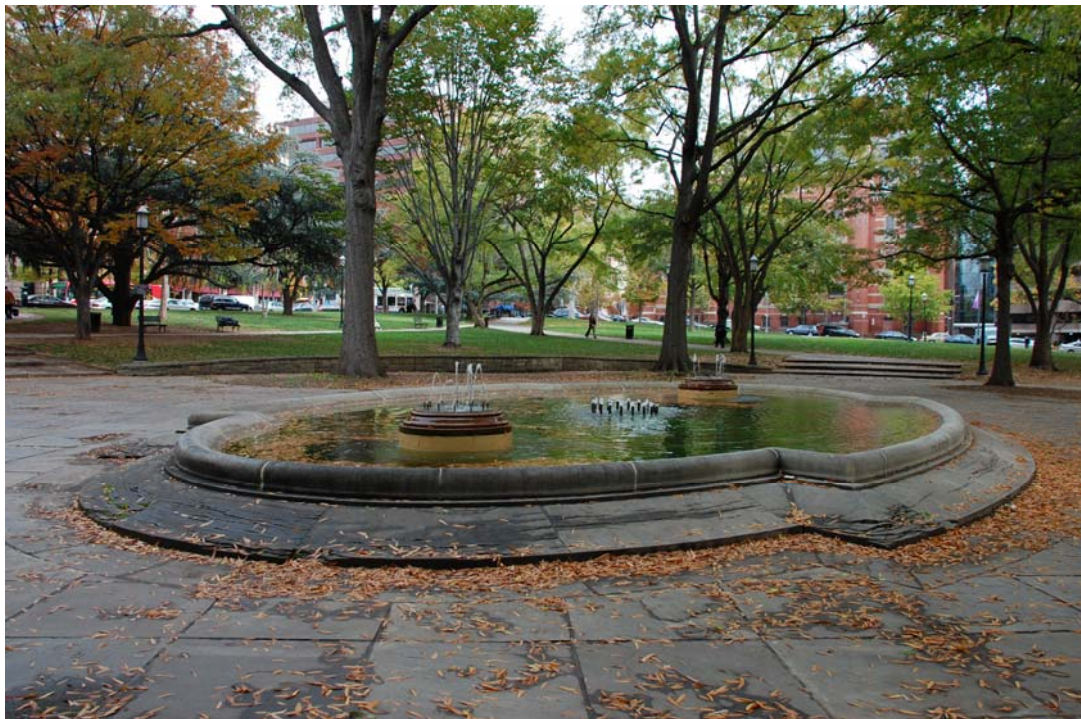
Figure 2 – View to central fountain at Franklin Square

<i>Park Elements</i>	<i>N/A</i>	<i>Poor</i>	<i>Adequate</i>	<i>Good</i>	<i>Comments</i>
Fountain			x		The central fountain is operational. There are three groupings of jet sprays which are low and rather subtle. Continued maintenance should be a priority to remove debris and keep the appearance of the fountain optimal. Deterioration is evident in the sandstone coping around the base of the fountain. Future repair or replacement of the coping could be considered.
Path Paving		x			Deterioration of the existing bituminous path pavement over concrete is extensive. An attempt to patch with asphalt has not been successful. The uneven pavement presents a safety concern and also results in drainage problems as pavement does not direct water into drains. Path improvements should be a priority.
Plaza Paving				x	The square flagstone paving in the central plaza is in good condition. Limited settlement has occurred and should be corrected to eliminate low spots in paving.

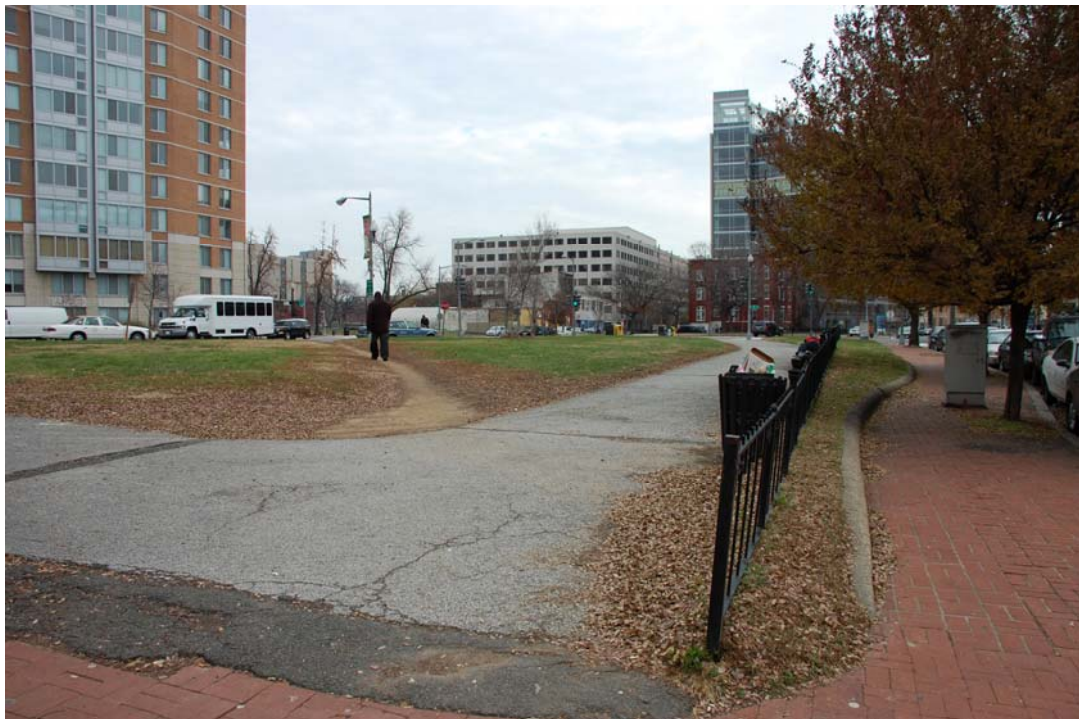
- Broad walks line the west and south inner edges of the park defining areas for seating along the perimeter. Paths have been worn through the lawn crossing to Massachusetts and near the corner of 4th and Eye Streets.
- Brick sidewalks define the outside boundary of the park along the surrounding streets.

Figure 2 – View north-east to Reservation 72

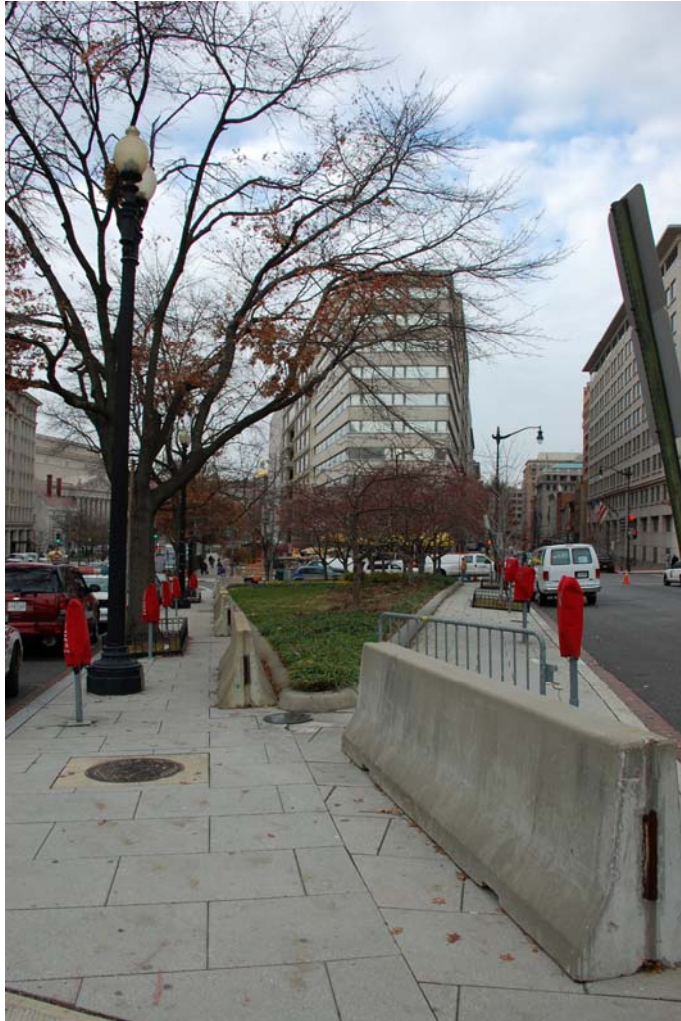
- The site is within visual proximity of the Moultrie Courthouse and the future National Law Enforcement Museum. The visual clutter of the jersey barriers and security do not promote attractive views to or from the site.

Figure 2 – View west to Reservation 187
